# Manhole Inspection Summary

Manhole # S45II\_048MH

Insp Date: **4/30/08 7:43 AM**

**Location** Address: **Chester St**

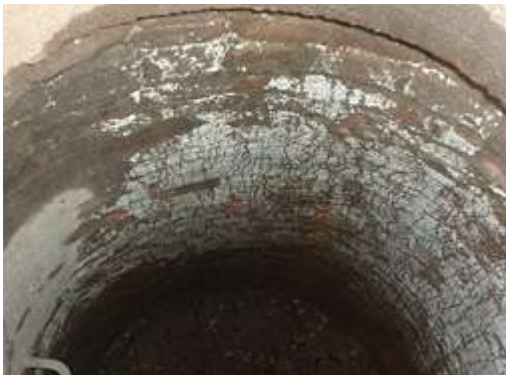
Defect 2

Infiltration

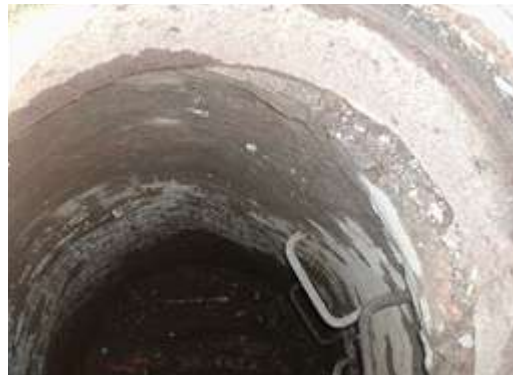
Defect 1

infiltration

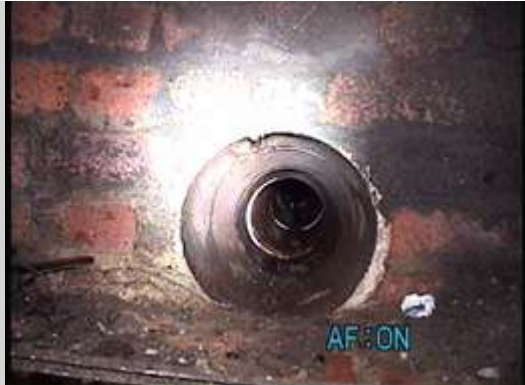
12 O'Clock Outflow

8 in. Circular Gravity Sewer  
Pipe Out @ 12 O'Clock

Infiltration: **None** Pipe Seal Cond: **Sound**
